**BULLETIN OF THE
SERVICE CITIZENS OF DELAWARE**

**GENERAL REPORT ON
SCHOOL BUILDINGS AND GROUNDS
OF DELAWARE**

OCTOBER 15, 1919

GEORGE D. STRAYER

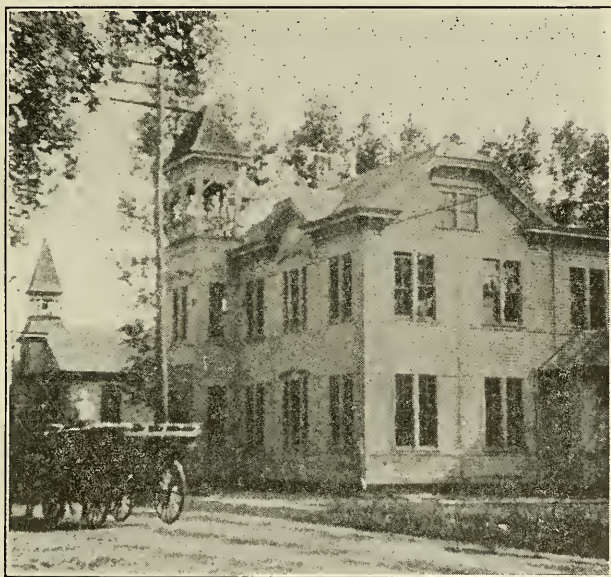
FELTON SCHOOL

deceptive. The very low score of 261 points is a measure of its effectiveness for school purposes rather than its appearance. The site is so small as to be entirely inadequate to the needs of so large a school, and the building proper, scoring only 49 points out of a possible 165, is sufficient in itself to condemn the plant. The measure of the building in meeting the problems of the health and comfort of the children is indicated by the score of 40 out of 280 for service systems. The lighting of the class rooms is bad throughout. One

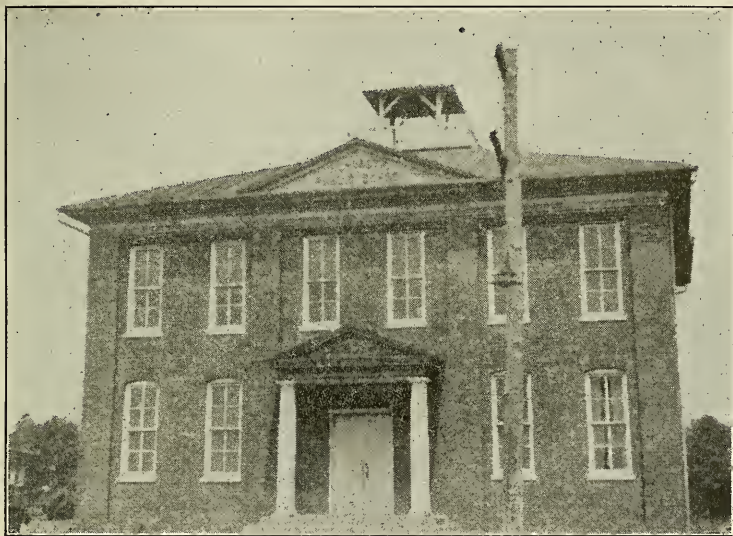
REHOBOTH SCHOOL

This building is a six-room, two-story brick structure, built in 1908. It is in good condition externally, but is a cheap type of construction, with tin roof and unfinished basement. In planning the interior of the building no consideration has been given to the standards of modern school architecture. The class rooms are irregular in shape, poorly arranged and lighted from two sides. The stairway and corridor arrangement is extremely bad and entails considerable fire risk. The opening through which the occupants of the three upper story rooms would have to pass in case of fire is but 41 inches

which case nothing short of a complete renovation of the building, excavation and improvement of the basement, additions of special room and the installation of fire escapes will make the building acceptable.

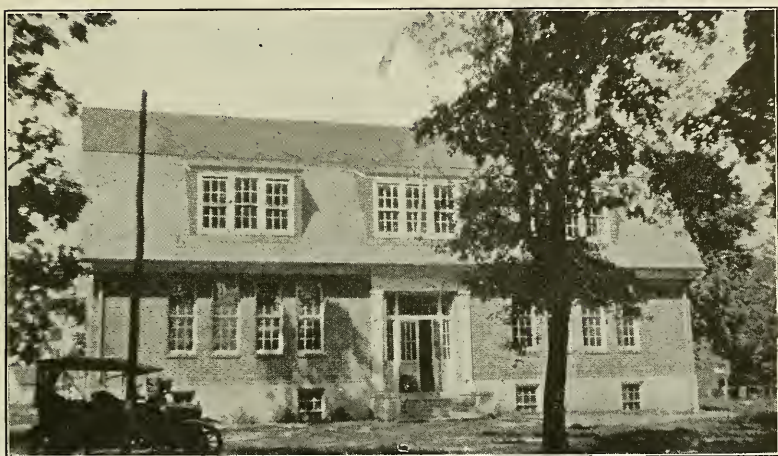
TOWNSEND SCHOOL

The commission regrets to announce to the well-intentioned citizens of Townsend that their new building scores but 536 points out of 1000. While this is one of the highest scores recorded in the county, it might have been 300 to 400 points higher with comparatively little additional cost.

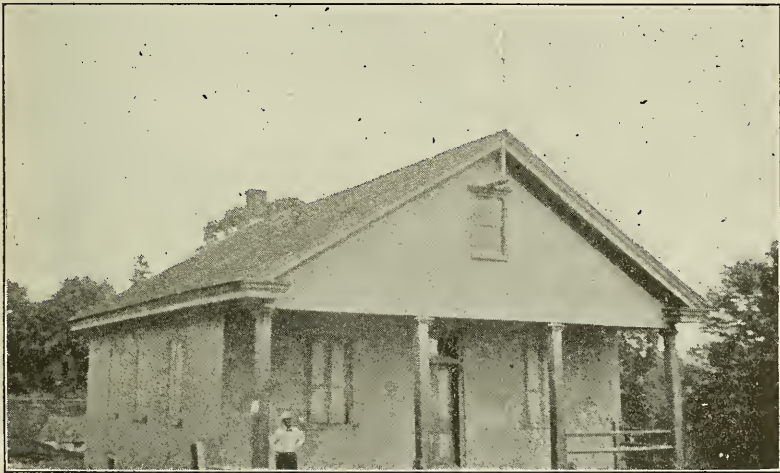
CLINTON, DISTRICT NO. 28

The Clinton School is a one-room, cobble-stone structure, 30x33 feet in dimension, standing on a site 150 feet square. It presents a very unattractive external appearance, looks timeworn and gloomy. The addition of a full-length porch in front of the building and the partitioning off of cloak rooms at the entrance has added materially to the usefulness of the building for school purposes. It is, however, both with respect to site, location and building, impossible of adaptation to modern school requirements and should, therefore, be disposed of for some purpose other than that for which it was long ago constructed.

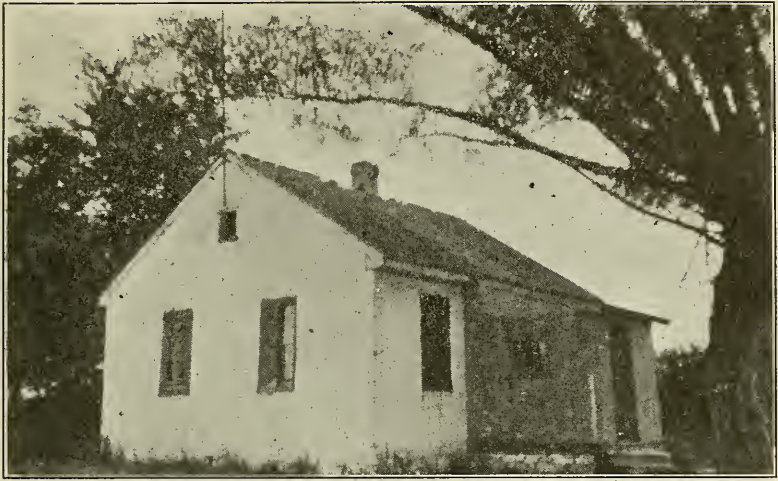
OGLETON SCHOOL

Ogleton is another of the old, very old, stone blockhouses. It is also located on one of the proverbial triangular sites in the fork of the roads. It possesses no single attribute which justifies its use for housing children. It is dark and depressing on the inside and unsightly from the outside. The toilets are in a very insanitary condition, vilely defaced and located within ten feet of the class room windows, which are the only source of ventilation. It is a crime

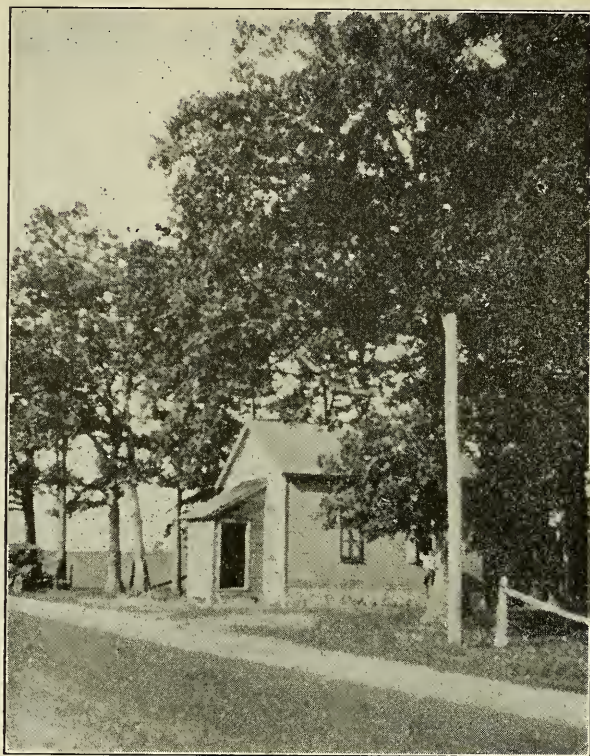
FIELDSBORO SCHOOL

points the building has. The building proper scores but 45 points in 200. The service systems are even lower in score than the very low score set by other buildings of the same general type. The class

room has nothing to recommend its further use. It is lighted from four sides. The blackboards are so poor as to score but 2 points out of 15 and the seats and desks but 2 in 30. The building should be closed and the children transported to a better building.

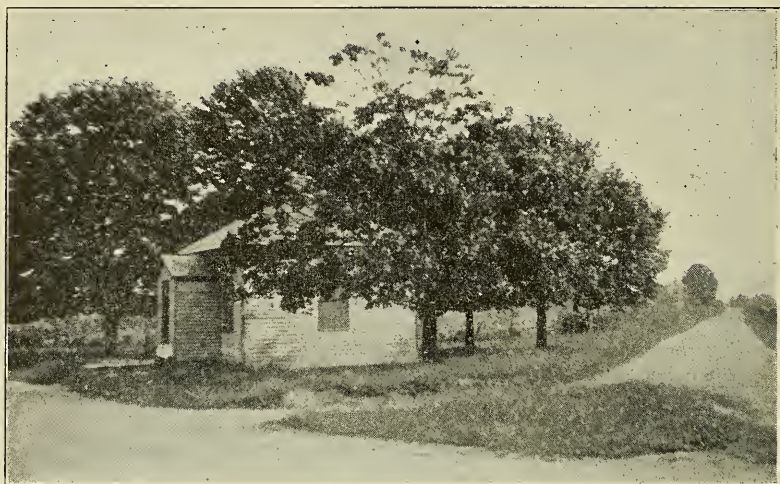
MILL LANE SCHOOL

The Mill Lane building is 18 feet square, seating 16 pupils, and located on a little triangular plot of land in the fork of the road. It does not fly the American flag. It is heated by a stove in the center

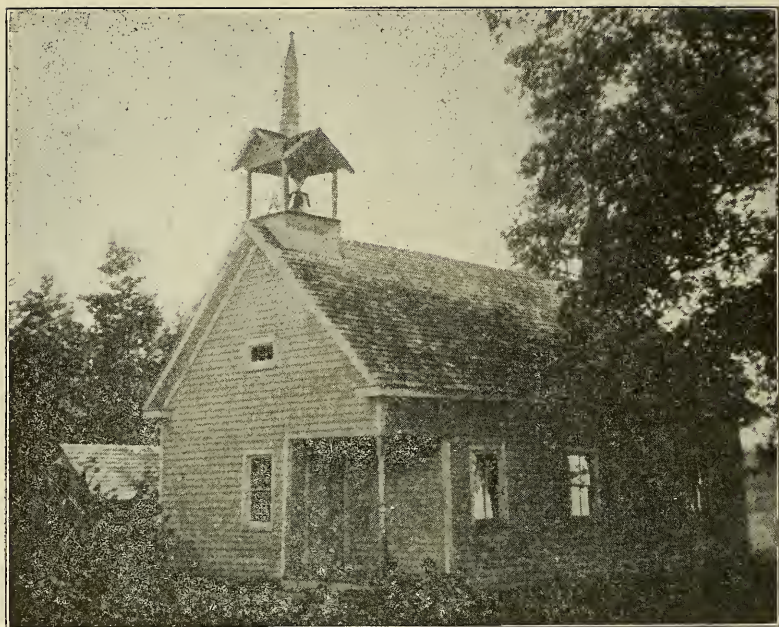
SANDTOWN SCHOOL

The Sandtown School is a one-room, frame structure, 18x28 feet, in fairly good condition, located on a site almost surrounded by dense woods. The location of the building on a shell road adds much to its accessibility, but the nature of its surroundings makes the extension of the present site undesirable. The building itself cannot be altered to provide amply for a modern educational program, and at the earliest possible date should be turned to some other

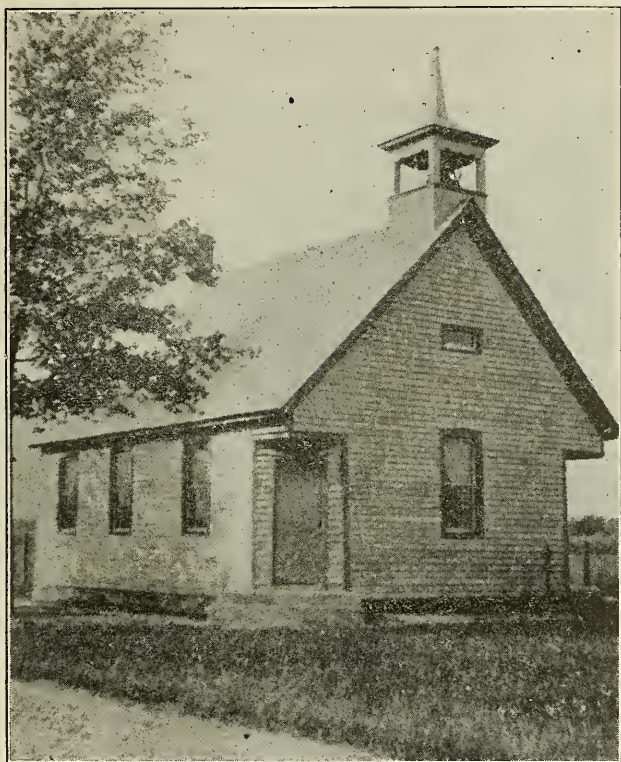
PETERSBURG SCHOOL

The Petersburg School is a comparatively new frame building with a well arranged vestibule, double entrance and concrete steps and walk. The building is in excellent repair, well painted, and the grounds are made as attractive as their size and form will permit. The site is, however, most unfortunately chosen, being, as it is, a

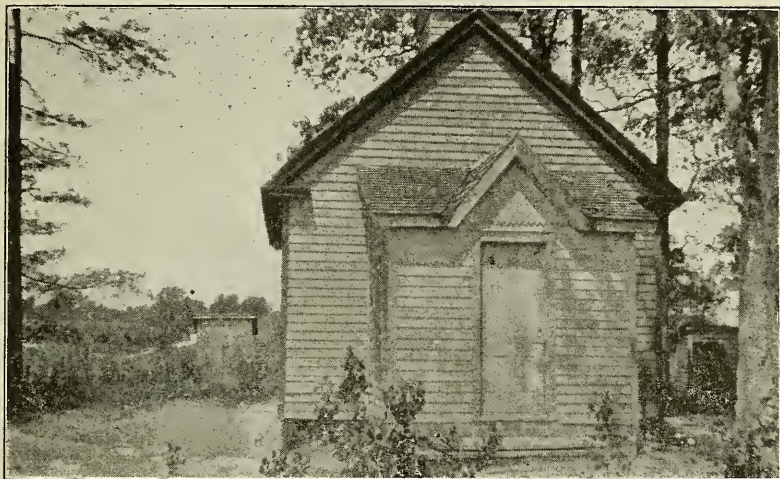
CEDAR GROVE SCHOOL

The site selected for this school is even more undesirable than the common run of undesirable sites in the county. It has about every undesirable feature possible. It is surrounded on two sides by low, swampy ground, is triangular in shape, and standing, as it does, on a little knoll, it has been washed so that there is no part of the surface that is not covered with deep gullies. It is obvious,

therefore, that there is no space anywhere except upon the road which passes by, in which children can play. The building is extremely old and in very bad condition. Little financial loss will be entailed in the complete abandonment of the entire plant. It will be noted from the detailed score on this building that it ranks among the lowest in the entire county. One of the toilets at this school, which apparently has not been cleaned out in years and which in consequence is extremely foul smelling, stands within fifteen feet of the windows of the classroom. This, together with the fact that the only provision for ventilation is through the windows of the building makes it a matter of very grave concern to the comfort and health of the children housed within.

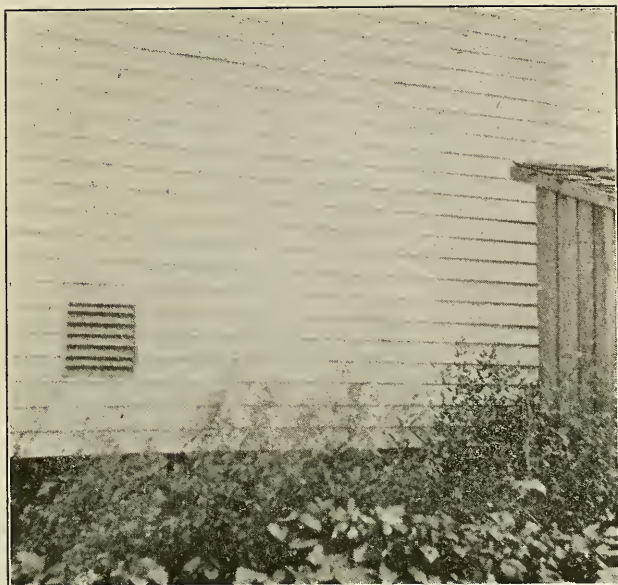
TRINITY NO. 73½

This old structure, hidden away as far as possible from the view of man in order that its dilapidated condition may not be known, is literally falling to pieces. Two or three jumps on the floor, on the part of an athletic person, might succeed in bringing the roof down upon his head. It is as near the pioneer type of school building as one can imagine. Its exterior is built of crudely milled boards, while its open brick foundation permits the wind to find its way with ease through the open cracks of the floor. The ceiling is only eight feet high and its joists still remain unhidden. The carved seats and broken-down stove belong to a previous generation of school equipment. The stove is peculiarly located in the center of the room with the teacher's desk between it and the front wall. It is conceivable that through this arrangement proper warmth is assured the teacher. It is hardly conceivable that the children at the outer walls ever experience a temperature of 67 degrees on cold winter days. In order to provide fuel, although the dense forest is immediately to the rear of the building, it apparently has been found necessary to appropriate clapboards from the wood shed. The homes in the immediate vicinity of this building are of the poorest type to be found in Delaware. They probably will remain of the poorest type as long as this building is used in its present state.

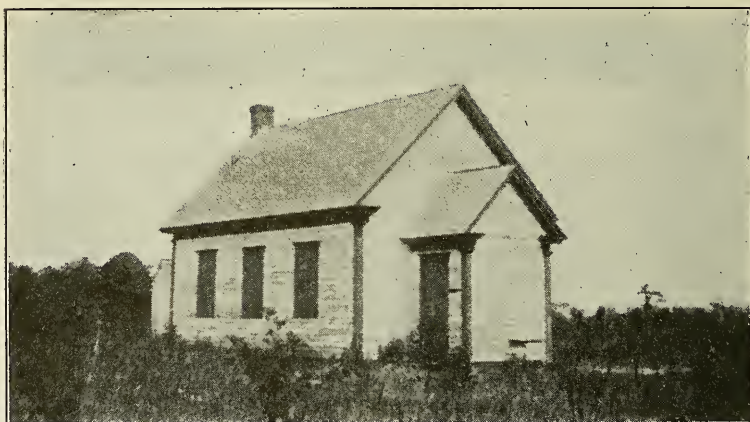
FAIRMOUNT NO. 82

Fairmount is a one-room structure with a ramshackle exterior but fair interior. It is located on an unattractive piece of land at a point where it does not appear to be accessible to a large number of children. It has an improved type of heater, wainscoting and pine board ceilings, and fair children's seats, although they are of the double variety. The toilets are located directly in the rear of the building and in close proximity to one another, without any barrier.

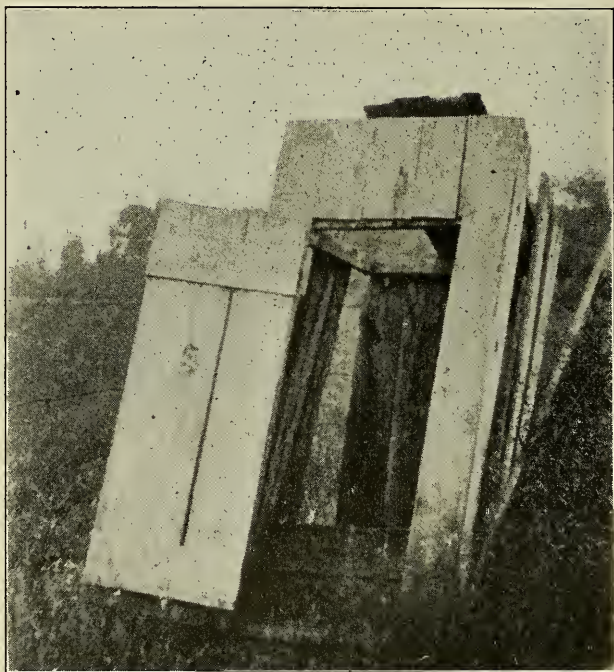
THE TOILET FOR THE COLORED CHILDREN OF THE WILLIAMSVILLE SCHOOL, DISTRICT NO. 113, NEW CASTLE COUNTY

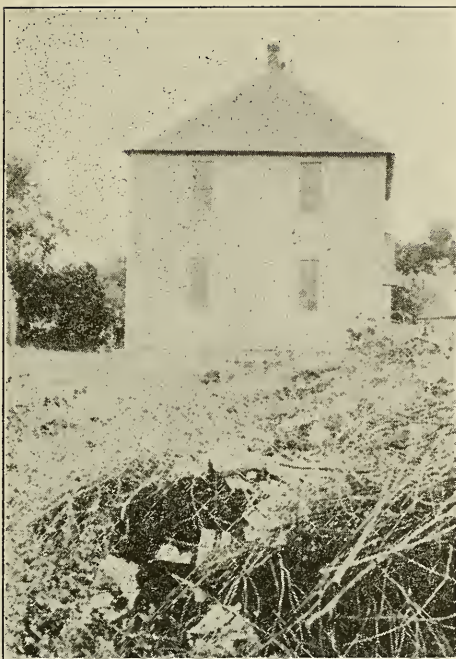
Colored school at Milford, Delaware. One of the best of the frame buildings provided for colored children in the special school districts. It is unfortunate that the dumpheap is in such close proximity to this school. The outhouses for this building were in the usual insanitary condition. The site is small and no conveniences provided for teachers or pupils. This four-room school will not provide the type of education that children of a democracy ought to be getting.
